2/16/11

Installation Technical Service Bulletin

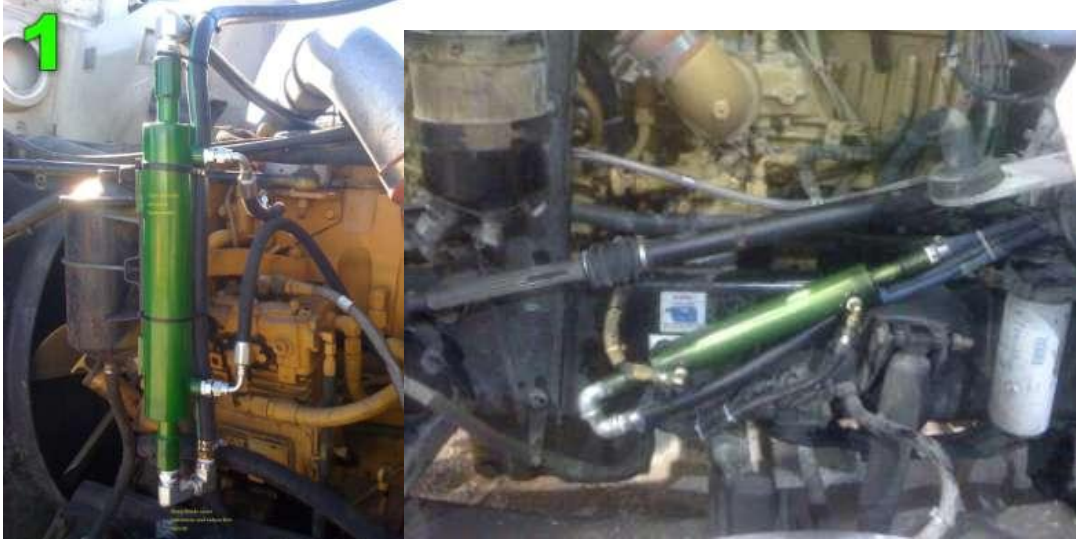
The common denominator we discovered is: 1 - the units were mounted on an extreme angle or vertical and 2 - the coolant piping on both units have a restriction in the method the coolant connections on one side are connected using 2- 90° elbows forming a hard 180° bend.

The velocity of the coolant flow is equally important as the temperature, we are not 100% sure why but we have our theories. The sharp bends become an issue in the fact that it causes a restriction in coolant flow velocity from cavitation and air pockets in the corners of the fittings.

In addition, mounting the units vertically or on a sharp angle can causes air pockets to accumulate in the fuel chamber on top of the unit or in its corners which also may affect the catalyst reaction.

Pictures of IMPROPER mounting and coolant plumbing.

The units must be mounted horizontally, grounded properly, preferably mounted on the engine, and must not exceed more than one sharp 90° elbow in the coolant connection and have constant coolant flow .

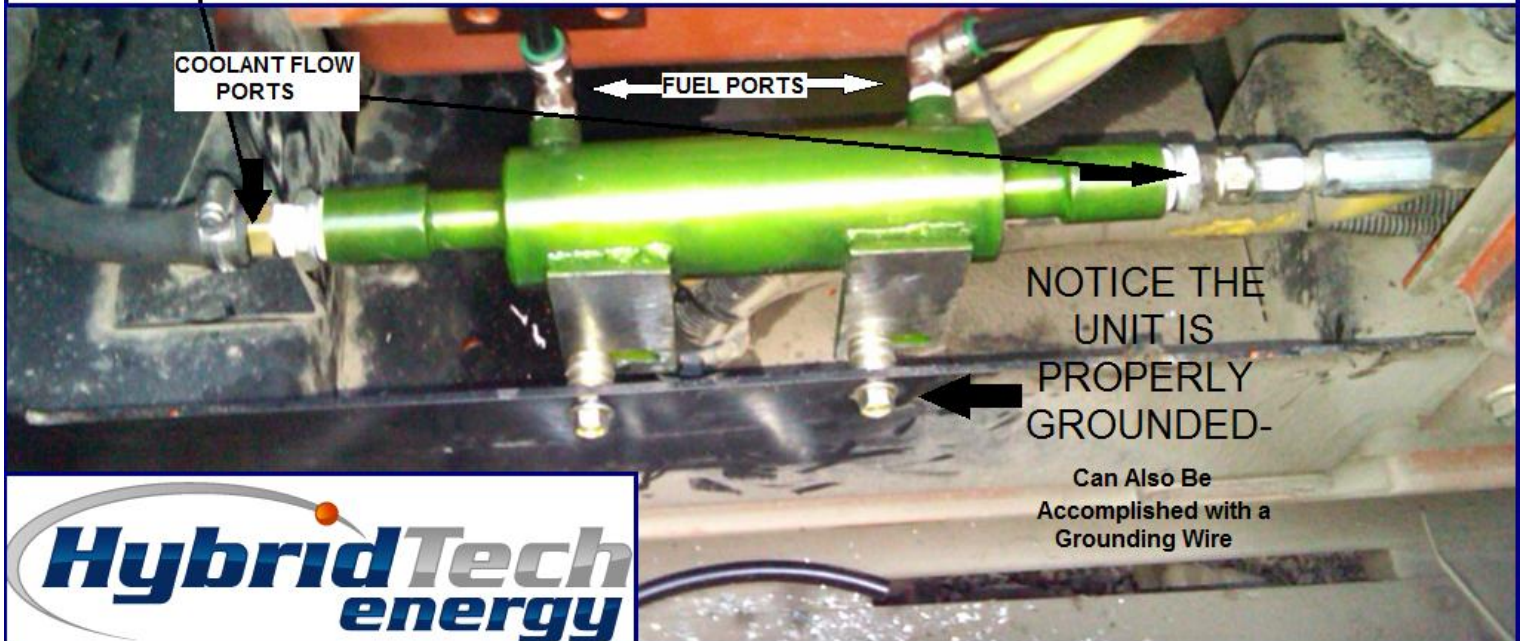
Notice: THIS IS A PROPER INSTALLATION

The unit pictured below is an example of a perfect and successful installation

No 90 Degree Angles or Elbows at Coolant/Water Flow Ports, this causes cavitation and loss of flow speed.

There are no angles on this successfully mounted unit's Coolant Flow Ports

This unit is also properly grounded to the frame of this drip pan, and it is mounted horizontally.

- 1.) Horizontal Mounting
- 2.) No Right or Acute Angles at the Coolant Flow Ports
- 3.) Proper Grounding, Metal to Metal (Can use a grounding wire)
